✓
Special Report 80-25

June 1980

**ROOFS IN COLD REGIONS: MARSON'S
STORE, CLAREMONT, NEW HAMPSHIRE**

Wayne Tobiasson and Charles Korhonen

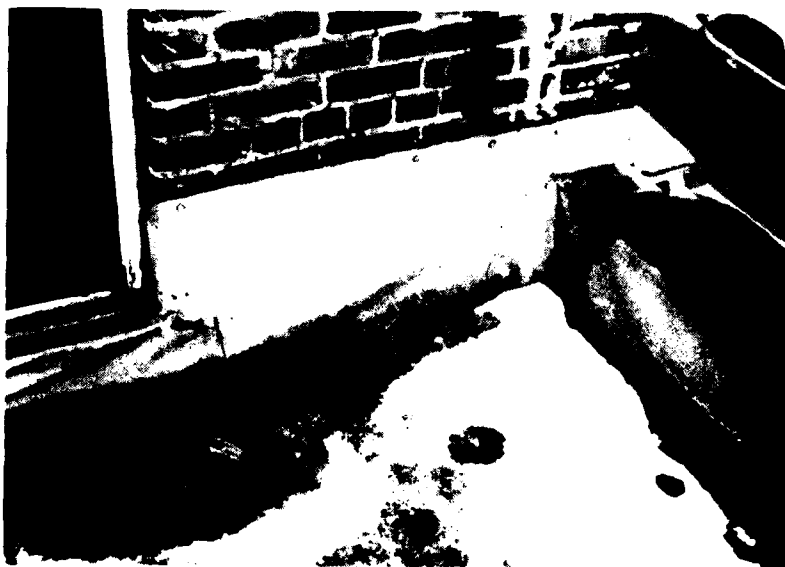
Flashings around penetrations such as plumbing vents (Fig. 8) and air exhaust-stacks (Fig. 9) were tight. Flashings at the chimney (Fig. 10), at the parapet near the front of the building (Fig. 11 and 12), and at the windows where the higher building abuts this roof (Fig. 13) were also secure.

Figure 13. Flashing details at windows (note poor condition of brickwork).

Diagonal wrinkles were the only visual sign of concern that we detected. They are evident in Figures 10-14 and suggest that some membrane shrinkage has occurred. However, the membrane had not pulled away from the vertical walls at any of these locations; we could push back against a solid object wherever we tried.
